## **Stormwater Quality Benefits of a Porous Asphalt Overlay**

Michael E. Barrett  
Center for Research in Water Resources, PRC #119, University of Texas, Austin, TX 78712  
PH (512) 471-0935  
FAX (512) 471-0072  
email: [mbarrett@mail.utexas.edu](mailto:mbarrett@mail.utexas.edu)

This project documents the impact of a porous asphalt overlay on the quality of highway stormwater runoff. A porous asphalt overlay, also known as a permeable friction course (PFC) or open graded friction course (OGFC), is a layer of porous asphalt approximately 50 mm thick which is often applied on top of conventional asphalt highways to enhance safety and reduce noise. The quality of stormwater runoff from a four-lane divided highway in the Austin, Texas area was monitored before and after the installation of a PFC. Observed concentrations of total suspended solids and pollutants associated with particulate material were much lower in the runoff from the PFC than that derived from the conventional asphalt surface. Concentration reductions were observed for total suspended solids (92%), total lead (91%), total copper (47%), and total zinc (75%). Concentrations of chemical oxygen demand and total Kjelda

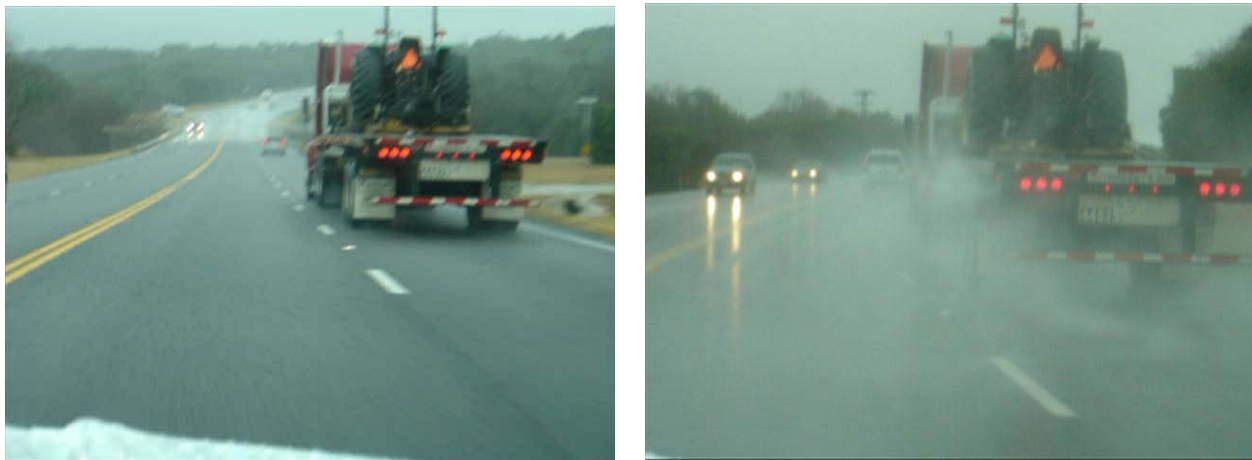
**FIGURE 1. Difference in Spray from Conventional and PFC Pavements**

Porous asphalt overlays are used increasingly by state transportation agencies, including those in Georgia, Texas, California, and Utah, to improve drivability in wet weather conditions and to reduce noise from highway traffic. Acknowledged benefits include reduced splash and spray, better visibility, better traction, reduced hydroplaning and less noise (2),(3). The dramatic difference in spray is illustrated in Figure 1, which shows the same truck passing from PFC to a conventional pavement. These pavements also may reduce the runoff volume and peak runoff velocity, as well as increase the lag time between rainfall and runoff, especially for smaller storm events.

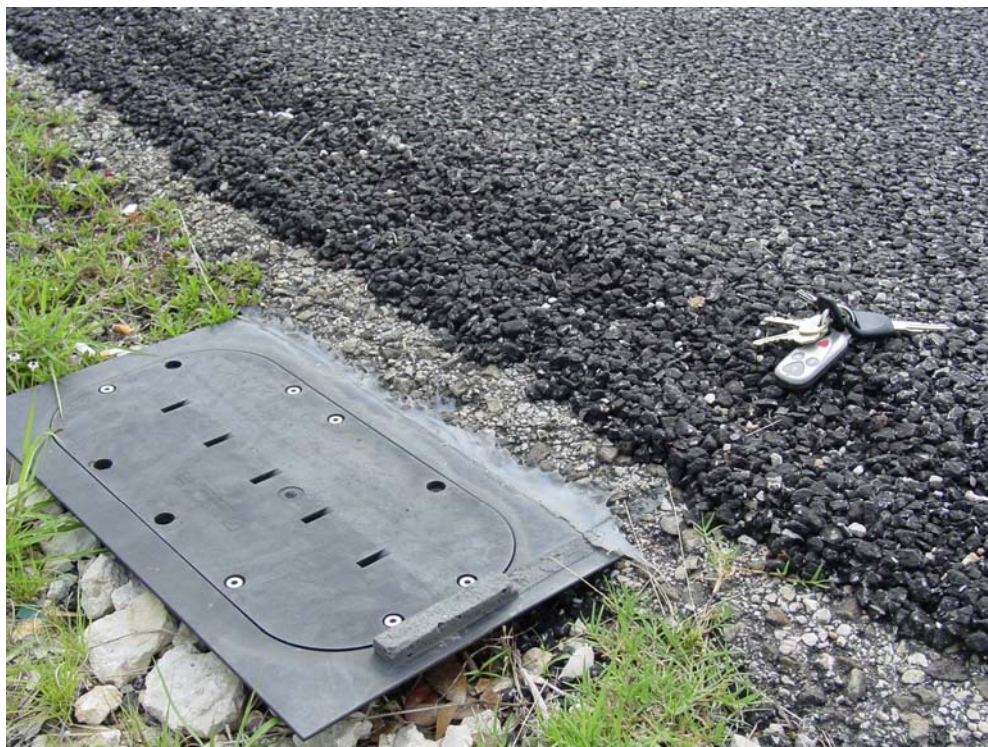
Because of the small length of pavement sampled and safety constraints on the roadside, it was not possible to instrument the site with automatic samplers, flow meters and recording rain gauges. Instead, GKY FirstFlush Samplers were installed to collect the runoff. These samplers collect runoff over a width of about 1 foot (300 mm), which means that the total area of roadway sampled was only about 34 ft<sup>2</sup> (3 m<sup>2</sup>) since the width of the road was 34 ft. and assuming that the roadway base had a constant slope. These passive stormwater samplers can hold up to 5L of water. The lid of each sampler is constructed with five sampling ports, each of which can be plugged to better control the rate at which collected runoff enters the sampler. Plastic flaps on the underside of each port function as closing mechanisms, preventing additional water from entering the sampler once capacity is reached. Each sampler is fitted with a 5L, removable plastic container and lid to allow for easy removal and transport of the sample. A picture of the edge of pavement sampler is presented in Figure 2. A rain gauge also was installed at the site to provide storm totals of rainfall.

**FIGURE 2 Photograph of installed sampler at edge of pavement.**

The GKY sampler was placed in a test flume and several calibration tests were run at flow depths of less than 0.25 inch (6 mm) to depths of 2 inches (50 mm) at Texas A&M University (unpublished) before installation. The shallow sheet flows gave very good performance requiring approximately 15- 45 minutes to collect a 1.3 liter sample depending on the number of openings unplugged. Although these are called “first flush” samplers, a substantial amount of rainfall was required to collect sufficient volume of runoff for analysis. The smallest event providing sufficient runoff volume was 0.5 inches (13 mm); consequently, this configuration allowed sampling of the entire storms for rainfall volumes less than about 1.5 inches (38 mm).

In October 2004, TxDOT implemented a PFC overlay project on a section of Highway 360. The overlay was applied on top of the existing conventional asphalt according to TxDOT specifications (9). The overlay is visible in Figure 2 and the coarse nature of this paving material is evident in this photograph. The lighter gray asphalt at the edge of pavement is the conventional surface below the PFC. Runoff sampling at the site was discontinued during the overlay installation and resumed upon completion of the overlay project. Runoff samples from

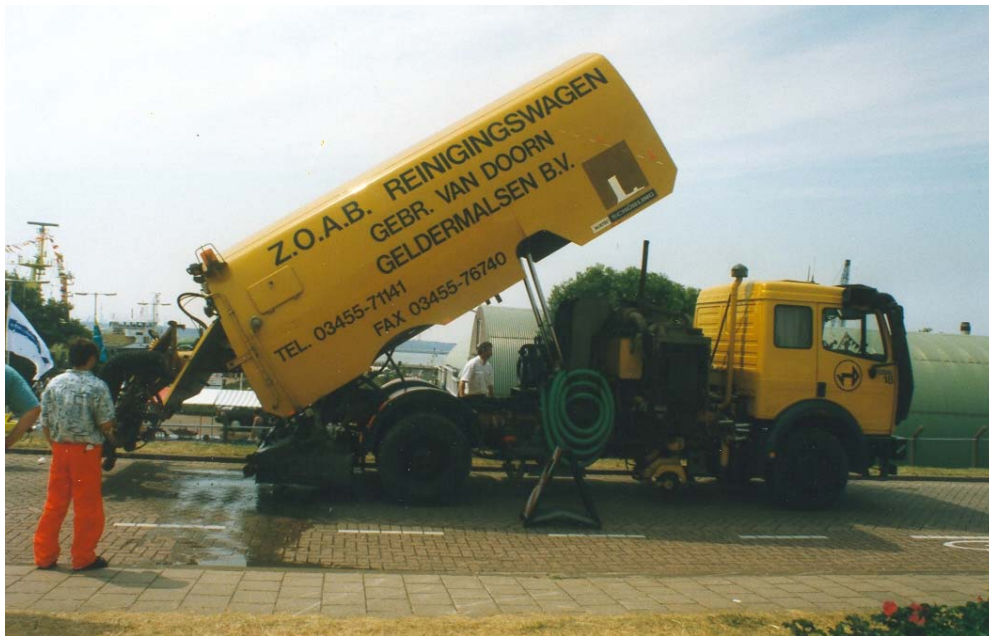
It has been demonstrated that an aggressive maintenance program that includes specially designed vehicles for cleaning the pavement can maintain the performance of PFC for a considerable period (3). These vehicles contain both pressure washing and vacuum equipment to remove the accumulated pollutants (Figure 6). In the Netherlands, this type of street cleaner is used to wash the hard shoulders twice a year to maintain performance. It seems unlikely that the water quality benefits will persist without some effort of this type. A long-term monitoring project to document changes in performance and to evaluate different maintenance strategies is recommended for future research.

**FIGURE 6 PFC (ZOAB in Dutch) cleaning machine.**

The type of equipment used for PFC cleaning in Europe has never been evaluated in the United States and its use might also improve the quality of runoff from conventional asphalt pavements. The problem with conventional sweepers is that they are substantially more effective for the larger particles and typically have had little impact on runoff quality (4). It is likely that street cleaning (as opposed to sweeping) would have to be conducted much more frequently on a conventional asphalt surface, because there is less room for storage of accumulated material in the surface roughness elements of conventional asphalt and this material is more subject to the forces of vehicle tires that can remobilize the accumulated pollutants.
